Manhole Inspection Summary

Manhole # S21KK_003MH

Insp Date: **5/31/07 12:07 PM**

Location Address: **1918 FULTON AVE**

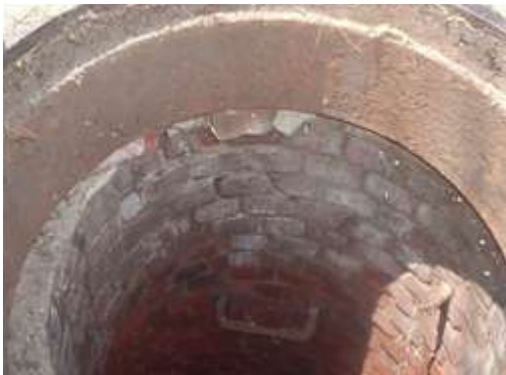
Defect 2

Condition: ☐ Sound ☐ Cracked ☐ Root Intrusion ☒ **Loose Brick** ☐ Deteriorated

LOOSE CHIMNEY BRICKS

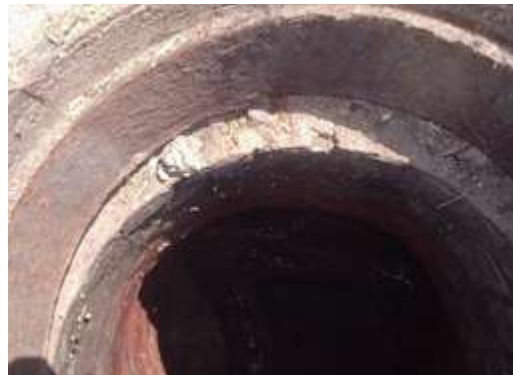
Defect 1

Frame Offset: **3** (in.) Condition: ☒ Sound ☐ Cracked ☐ Leaks

FRAME OFFSET

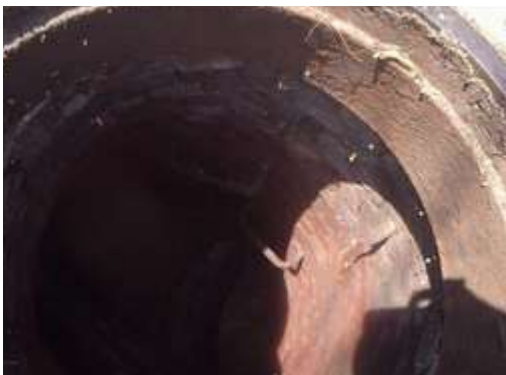
Defect 3

Steps Count: **4** Missing: **1** ☒ **Corroded**

CORRODED AND MISSING STEPS

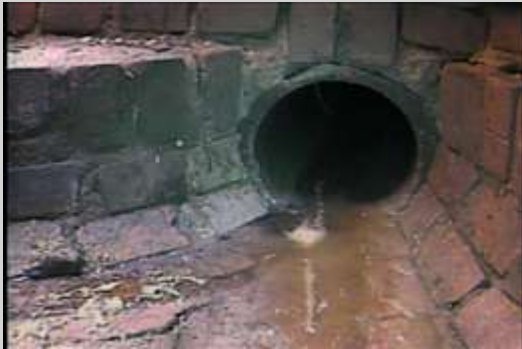
12 O'Clock Outflow

8 in. Circular Gravity Sewer
Pipe Out @ 12 O'Clock

Pipe Height: **8.4** (in.) Rod and Bar (Angled)
Pipe Material: **Clay** ☐ Pipe Lined
Invert Depth: **8.79** (ft.) Flow Characteristics: **Slow**
Deposits: ☒ None ☐ Mud ☐ Sludge ☐ Debris ☐ Grease
Silt Depth: (in.) Deposits Extent:
Infiltration: **None** Pipe Seal Cond: **Sound**

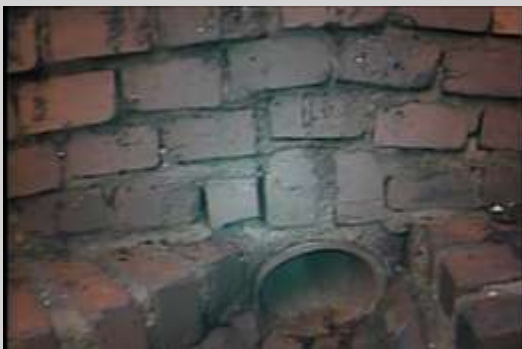
3 O'Clock Inflow

6 in. Circular Gravity Sewer
Pipe In @ 3 O'Clock

Pipe Height: **6** (in.) Rod and Bar (Angled)
Pipe Material: **Clay** ☐ Pipe Lined
Invert Depth: **8.68** (ft.) Flow Characteristics: **None**
Deposits: ☒ None ☐ Mud ☐ Sludge ☐ Debris ☐ Grease
Silt Depth: (in.) Deposits Extent:
Infiltration: **None** Pipe Seal Cond: **Sound**

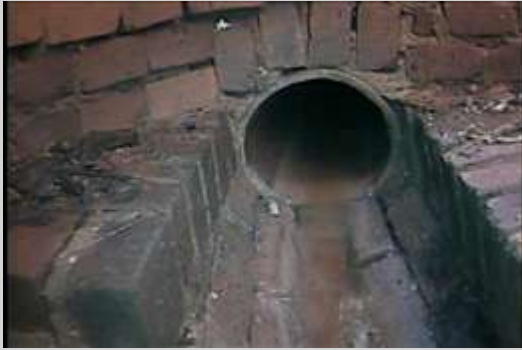
6 O'Clock Inflow

8 in. Circular Gravity Sewer

Pipe In @ 6 O'Clock

Infiltration: **None** Pipe Seal Cond: **Sound**

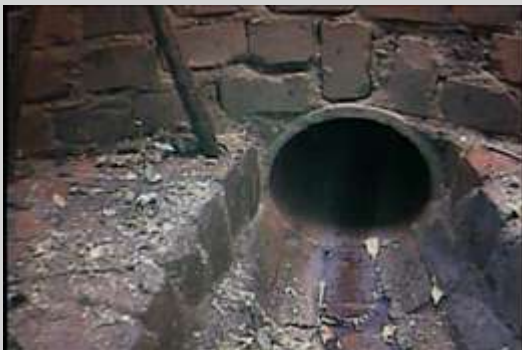
9 O'Clock Inflow

8 in. Circular Gravity Sewer

Pipe In @ 9 O'Clock

Infiltration: **None** Pipe Seal Cond: **Sound**
